Blackwood Creek Stream Channel Restoration

Reach 1 First Year Post Project Performance Monitoring

USDA Forest Service

December 2013

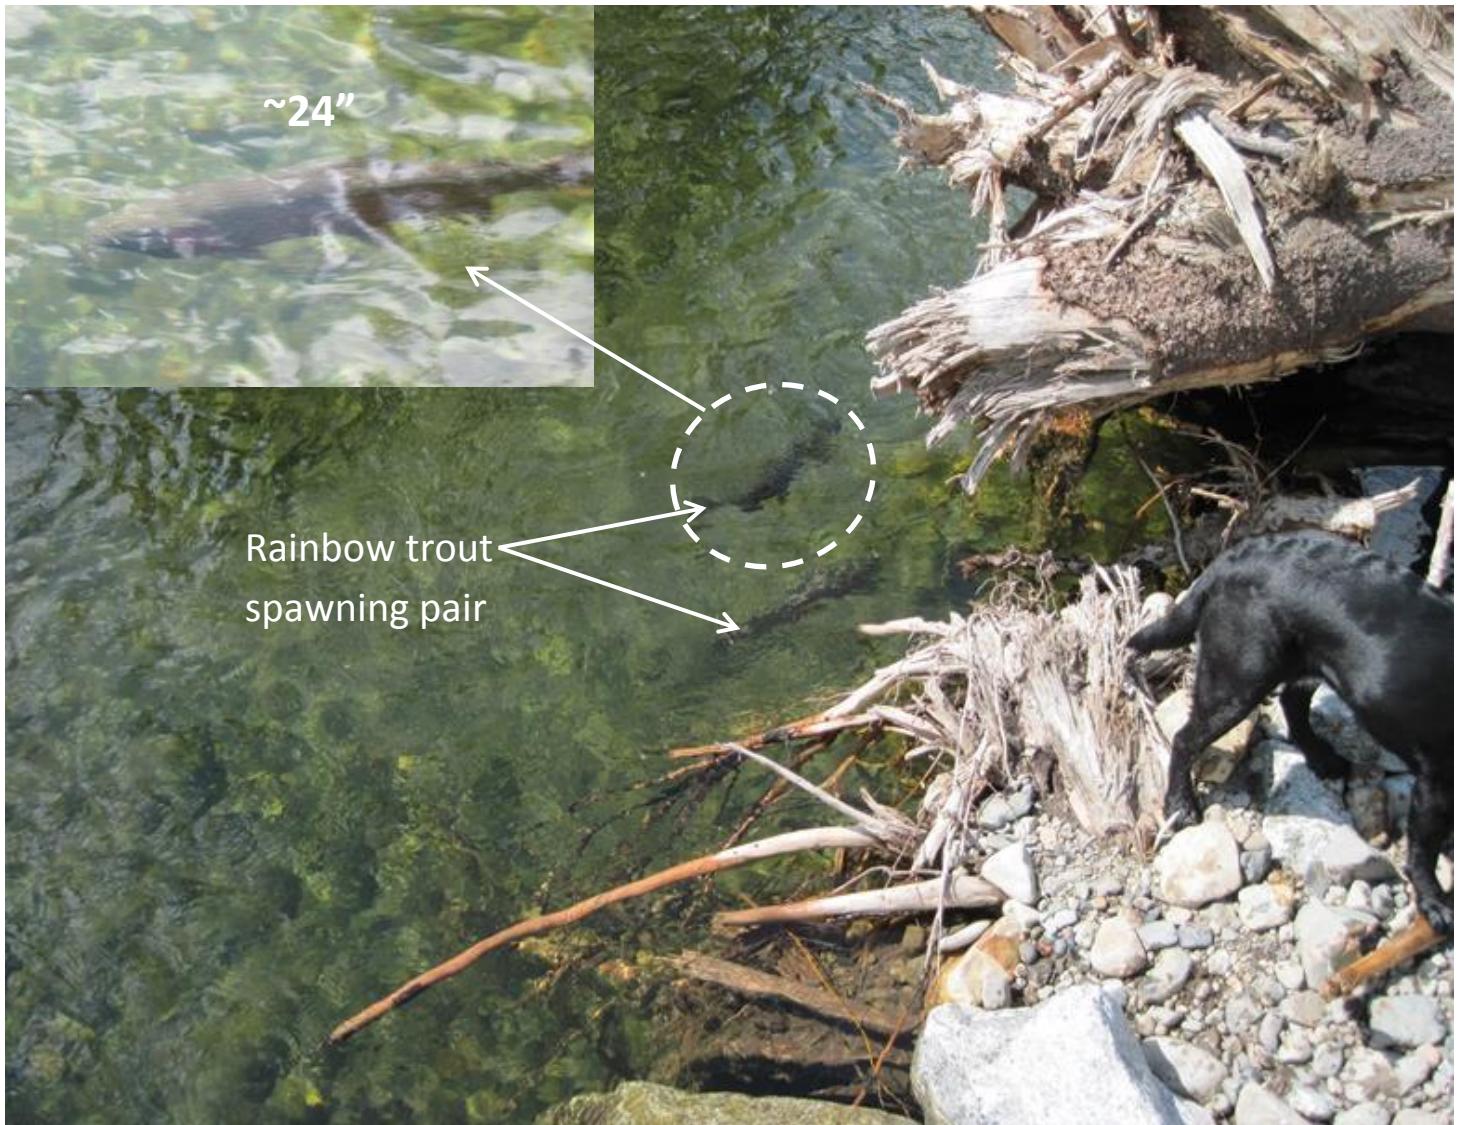
Photo taken in Reach 1 of two rainbow trout on their spring migration from Lake Tahoe up Blackwood Creek. This spawning pair was observed on 10 June 2013 by LTBMU hydrologic technicians conducting project area monitoring. The fish were seen using large wood debris jam constructed the previous summer for cover. Inset photo in upper left hand corner is a record of size and species. This fish is a 24" long Lake Tahoe rainbow trout.
